A LANDSLIDE NEAR EDMONTON

A THESIS

SUBMITTED TO THE FACULTY OF GRADUATE STUDIES  
IN PARTIAL FULFILMENT OF THE REQUIREMENTS FOR THE DEGREE  
OF MASTER OF SCIENCE

SPRING, 1971

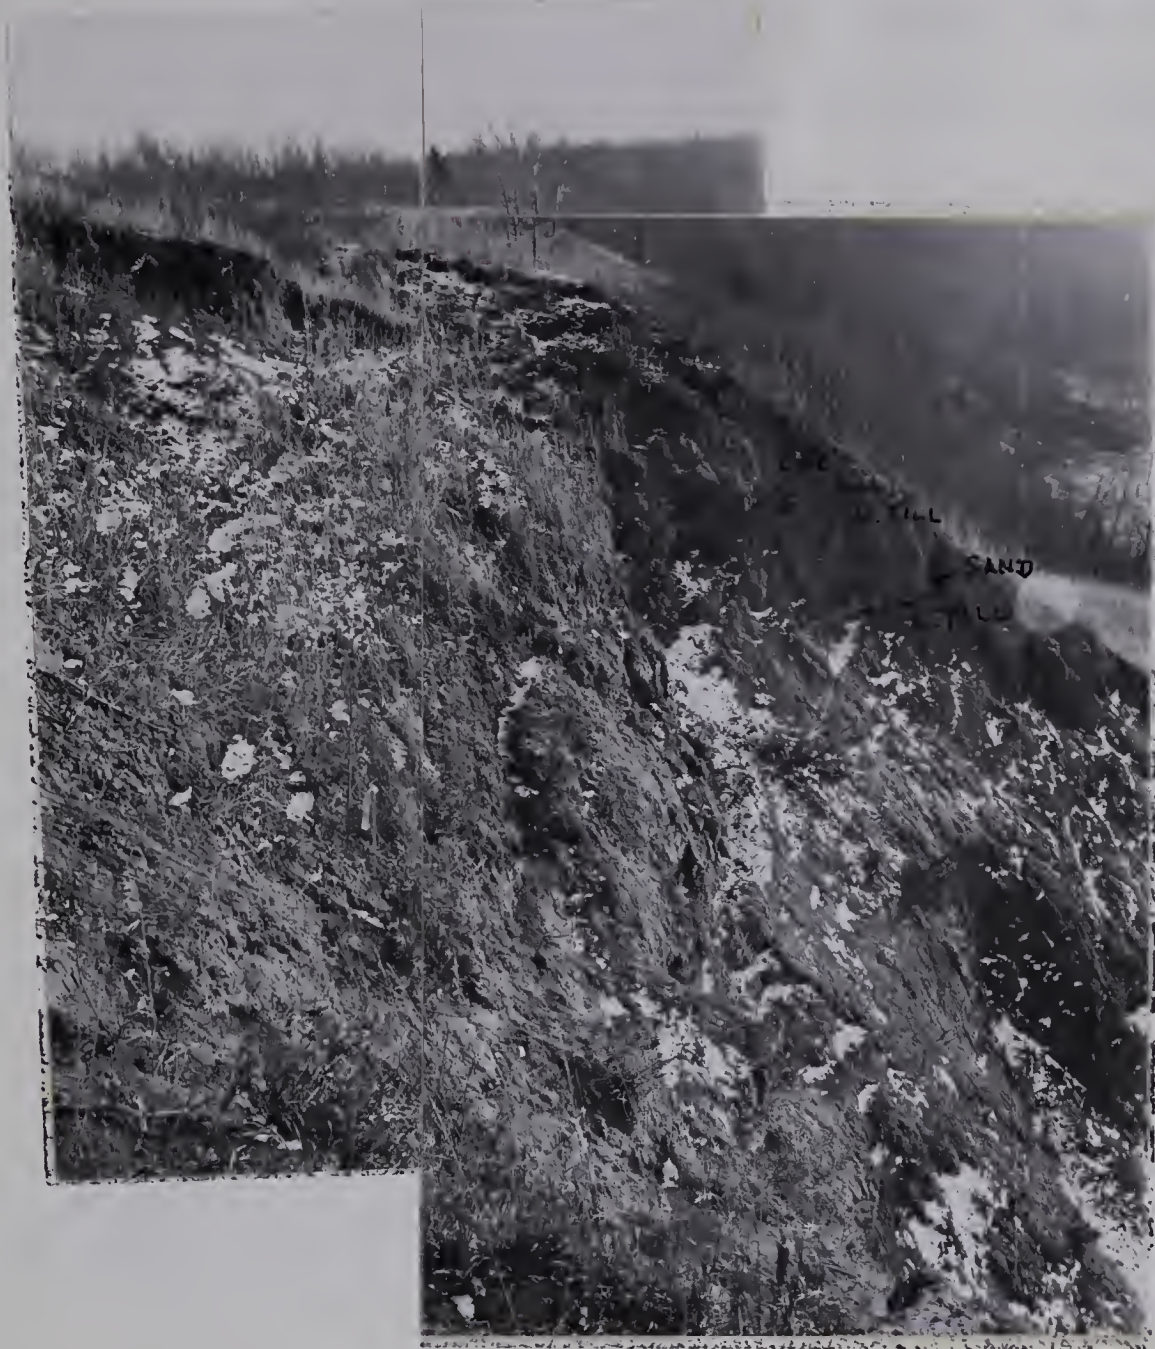
Figure 6. Upper central and southern scarp.

The slope of the scarp changes for each type of material exposed. The central portion increases with silt content from 35 degrees at the top to 45 degrees at the till contact (Figure 6). In the area between CL-6 and peg 2 the slope is steeper and appears to have sagged considerably. Cracks and large voids between blocks of till seem to point to a disturbed zone beneath the surface (Figure 7). Indeed, a vertical displacement of almost 8 feet was measured where material to the south is on the upthrown side.

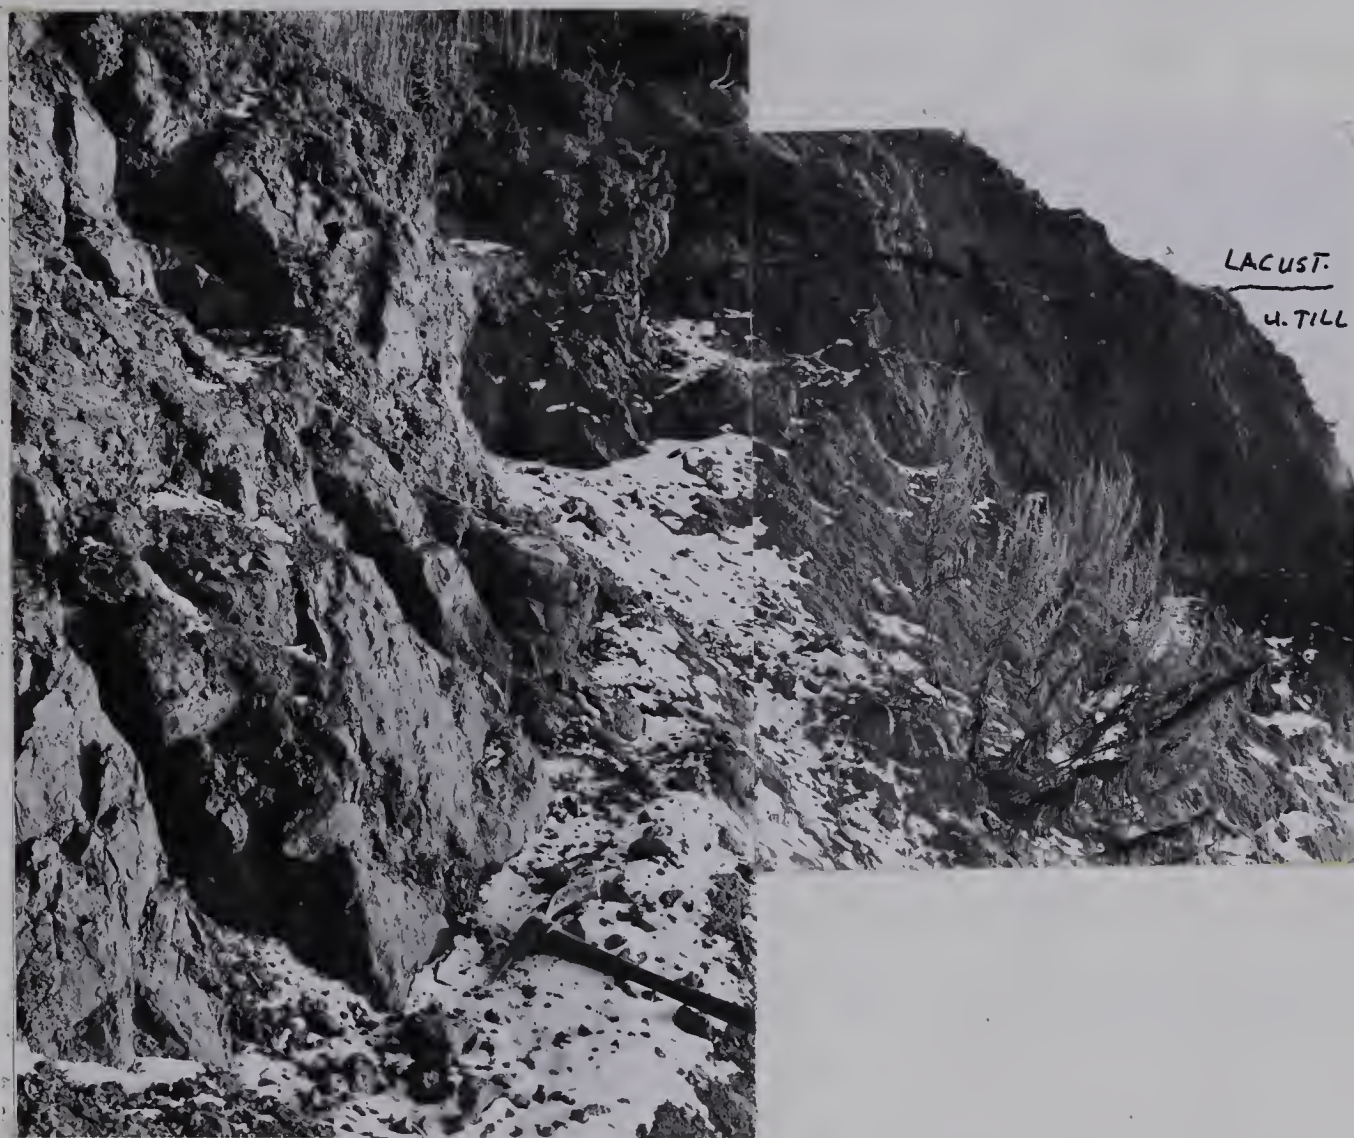
Figure 7. Fault zone below peg 2; left portion of photograph.

A relatively major shear fault zone due to earlier sliding was exhumed west of peg 2 and between pegs 3 and 5 (Figure 7). This fault is in line with and is the cause of the depression trending east through CL-7. It is dipping steeply to the north and disappears

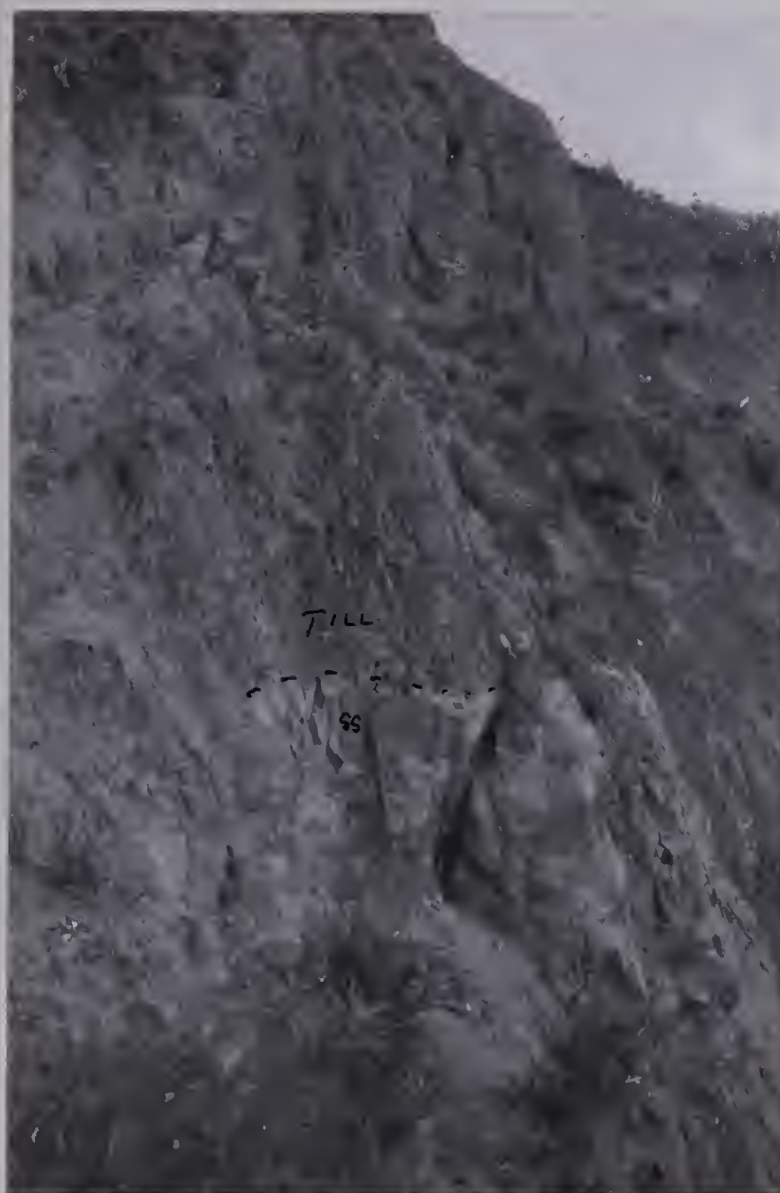
Figure 8. Paraconformable contact between till and sandstone on northern scarp. Note difference in slope between tills.

The lower till is dark grey and lightly stained, weak and finely fissured and rests at angles of between 35 and 55 degrees. It is mostly covered with fine debris. The contact with the Edmonton Formation below is nonconformable (Figures 8 & 9).

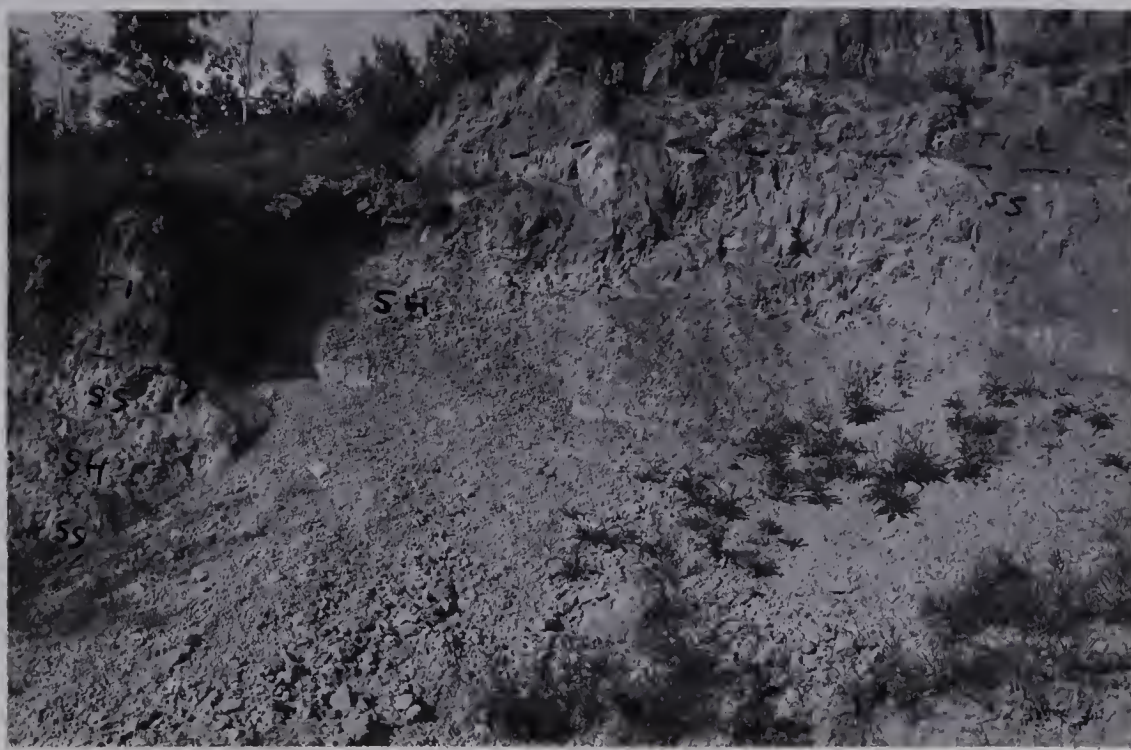
Figure 10. Till-sandstone contact exposed along northern scarp.

A striking feature is a thick lens of sandstone within the shales above the sandstone beds between pegs 10 and 11 (Figure 10). Its beds and contact planes strike east-west and dip 23 degrees north. The upper contact is nonconformable with shales but the lower contact

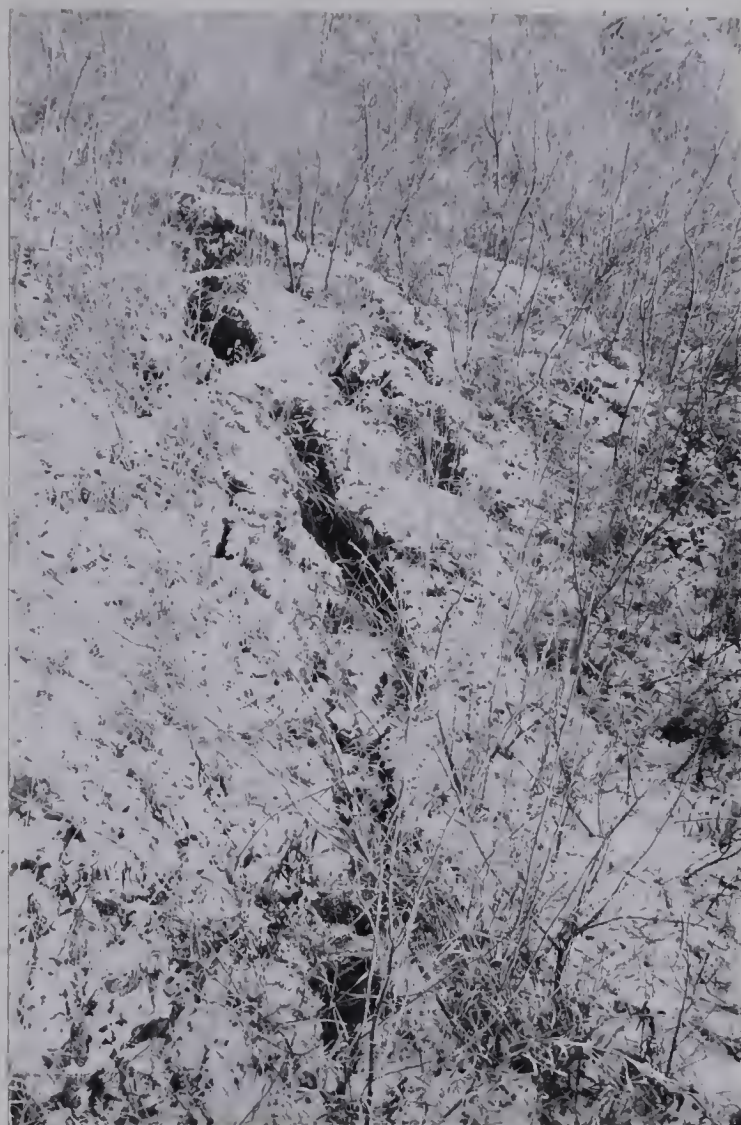
Figure 13. Tension cracks common on northern part of slide head that is underlain by till.

On the northern part of the head large, curvilinear shear and separation fractures are common (Figure 13). Till underlies most of the area, and lake deposits cap the east-central area. A 3-foot deep graben clearly marks the northernmost edge of the head and disappears under the talus. It does not reappear on the south side. Going southeast, from peg 54 the graben is at first 10 feet wide and 6 feet deep, then it widens to 25 feet in a depression at auger hole D-1, and then it rises until it finally disperses somewhere between pegs 30 and 31.

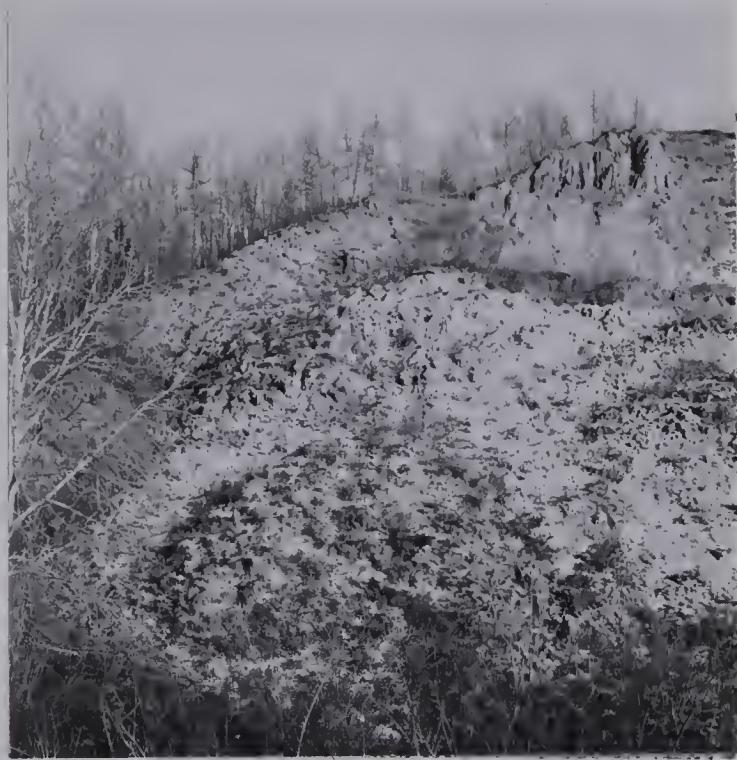
Figure 14. Northern section of slide.

portion of this northern area has a steeper and more variable slope than the lower portion. Its surface is fractured and quite rough, with blocks of sandstone outcropping, as for example around peg 57 (Figure 16). The strip between TL 22-23 and peg 56 is also quite steep, but the disturbed shales that outcrop here dip southerly at 25 to 28 degrees and are not completely disjointed (Figure 17). The lower portion is relatively smooth, evenly sloped, and lightly vegetated (Figure 14).

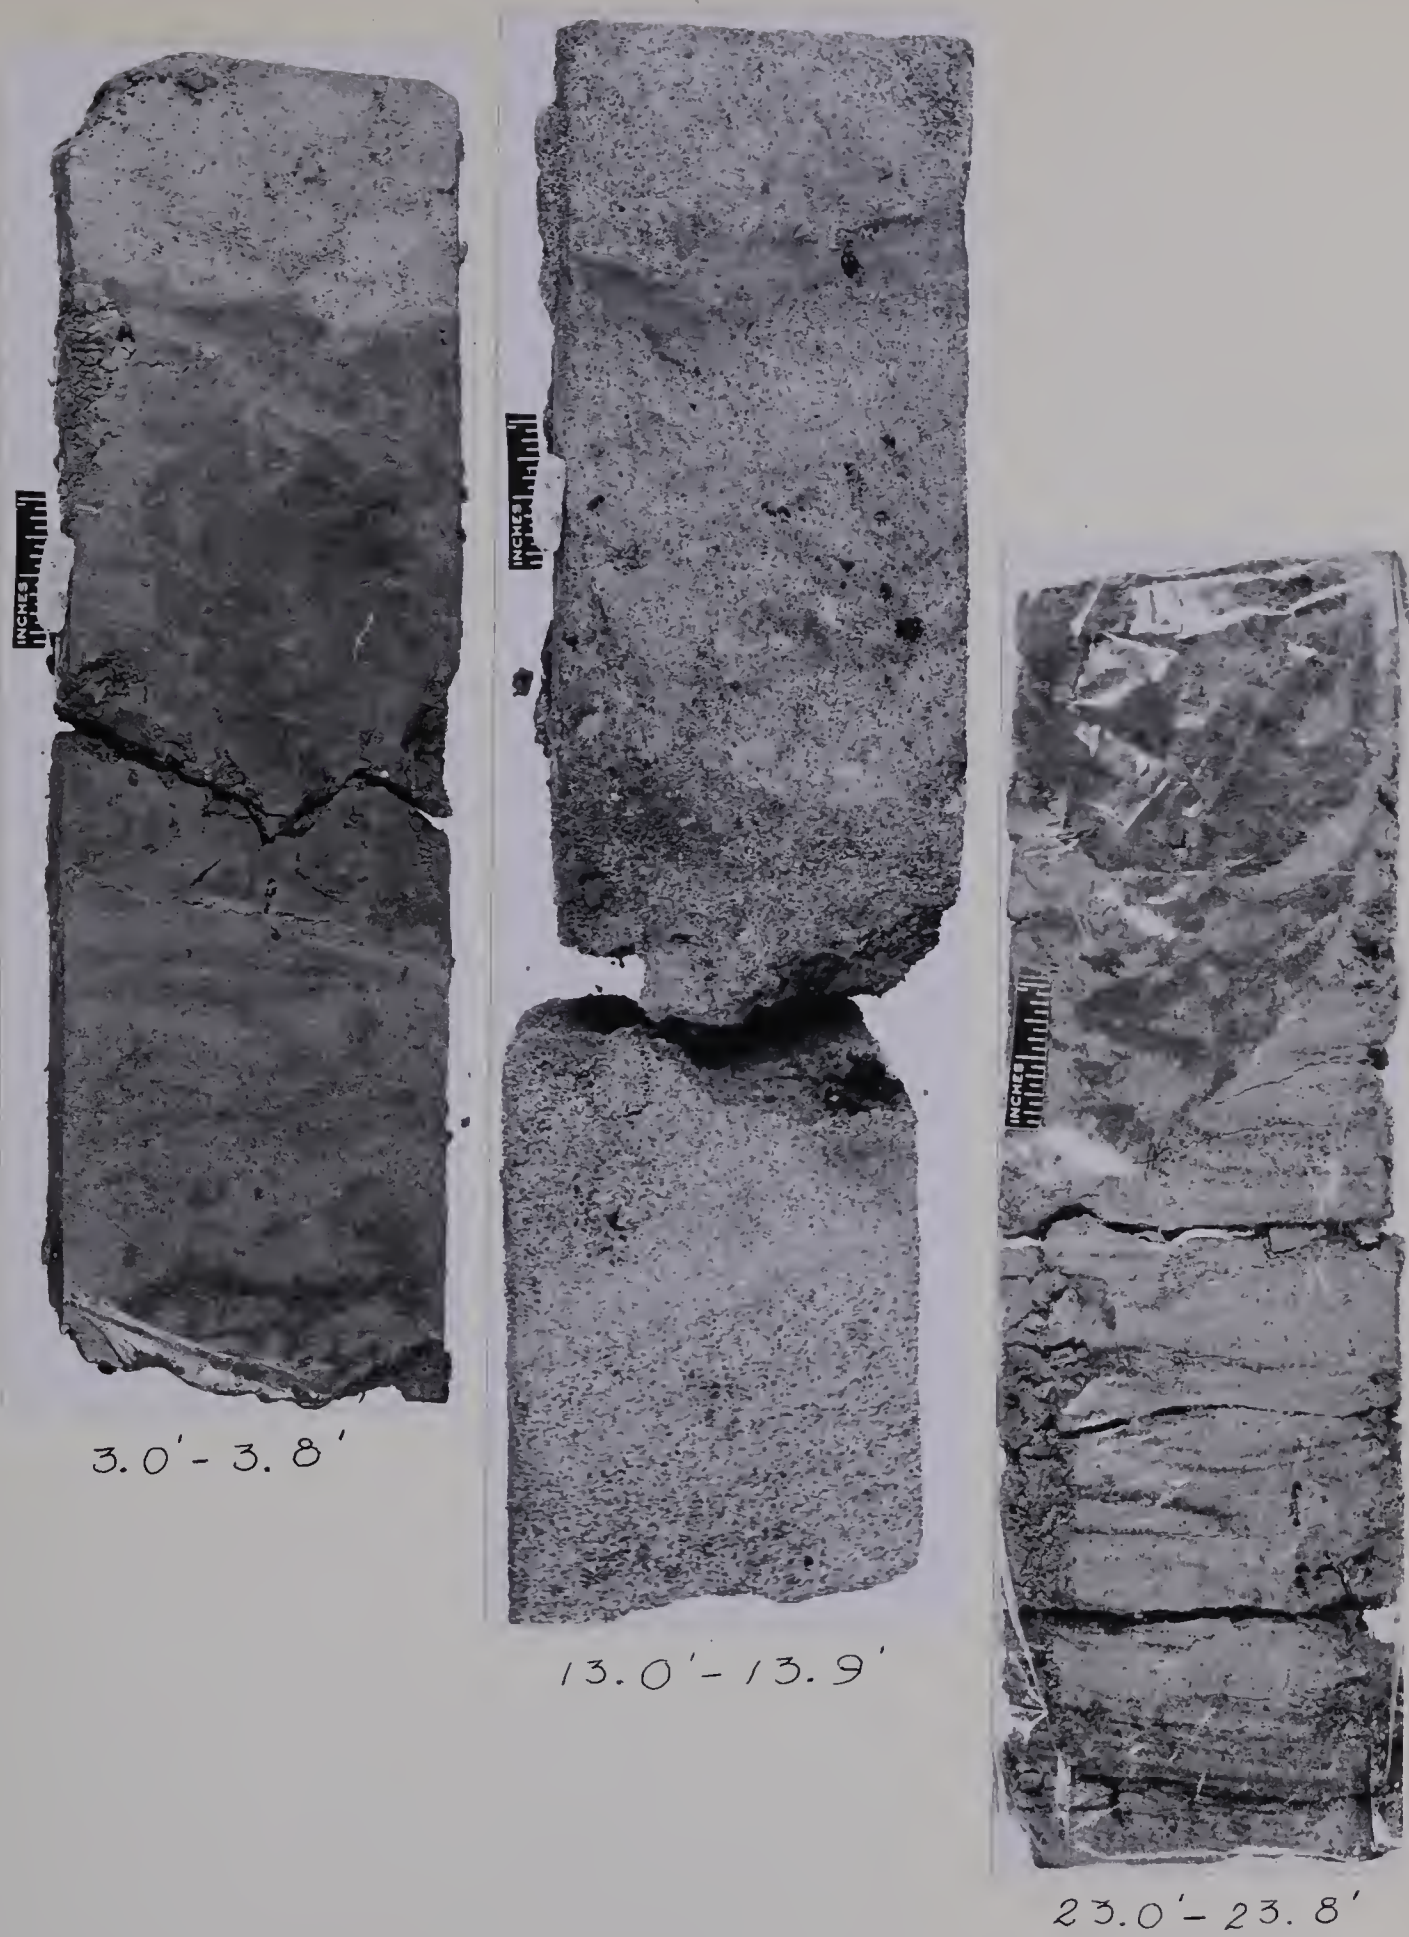
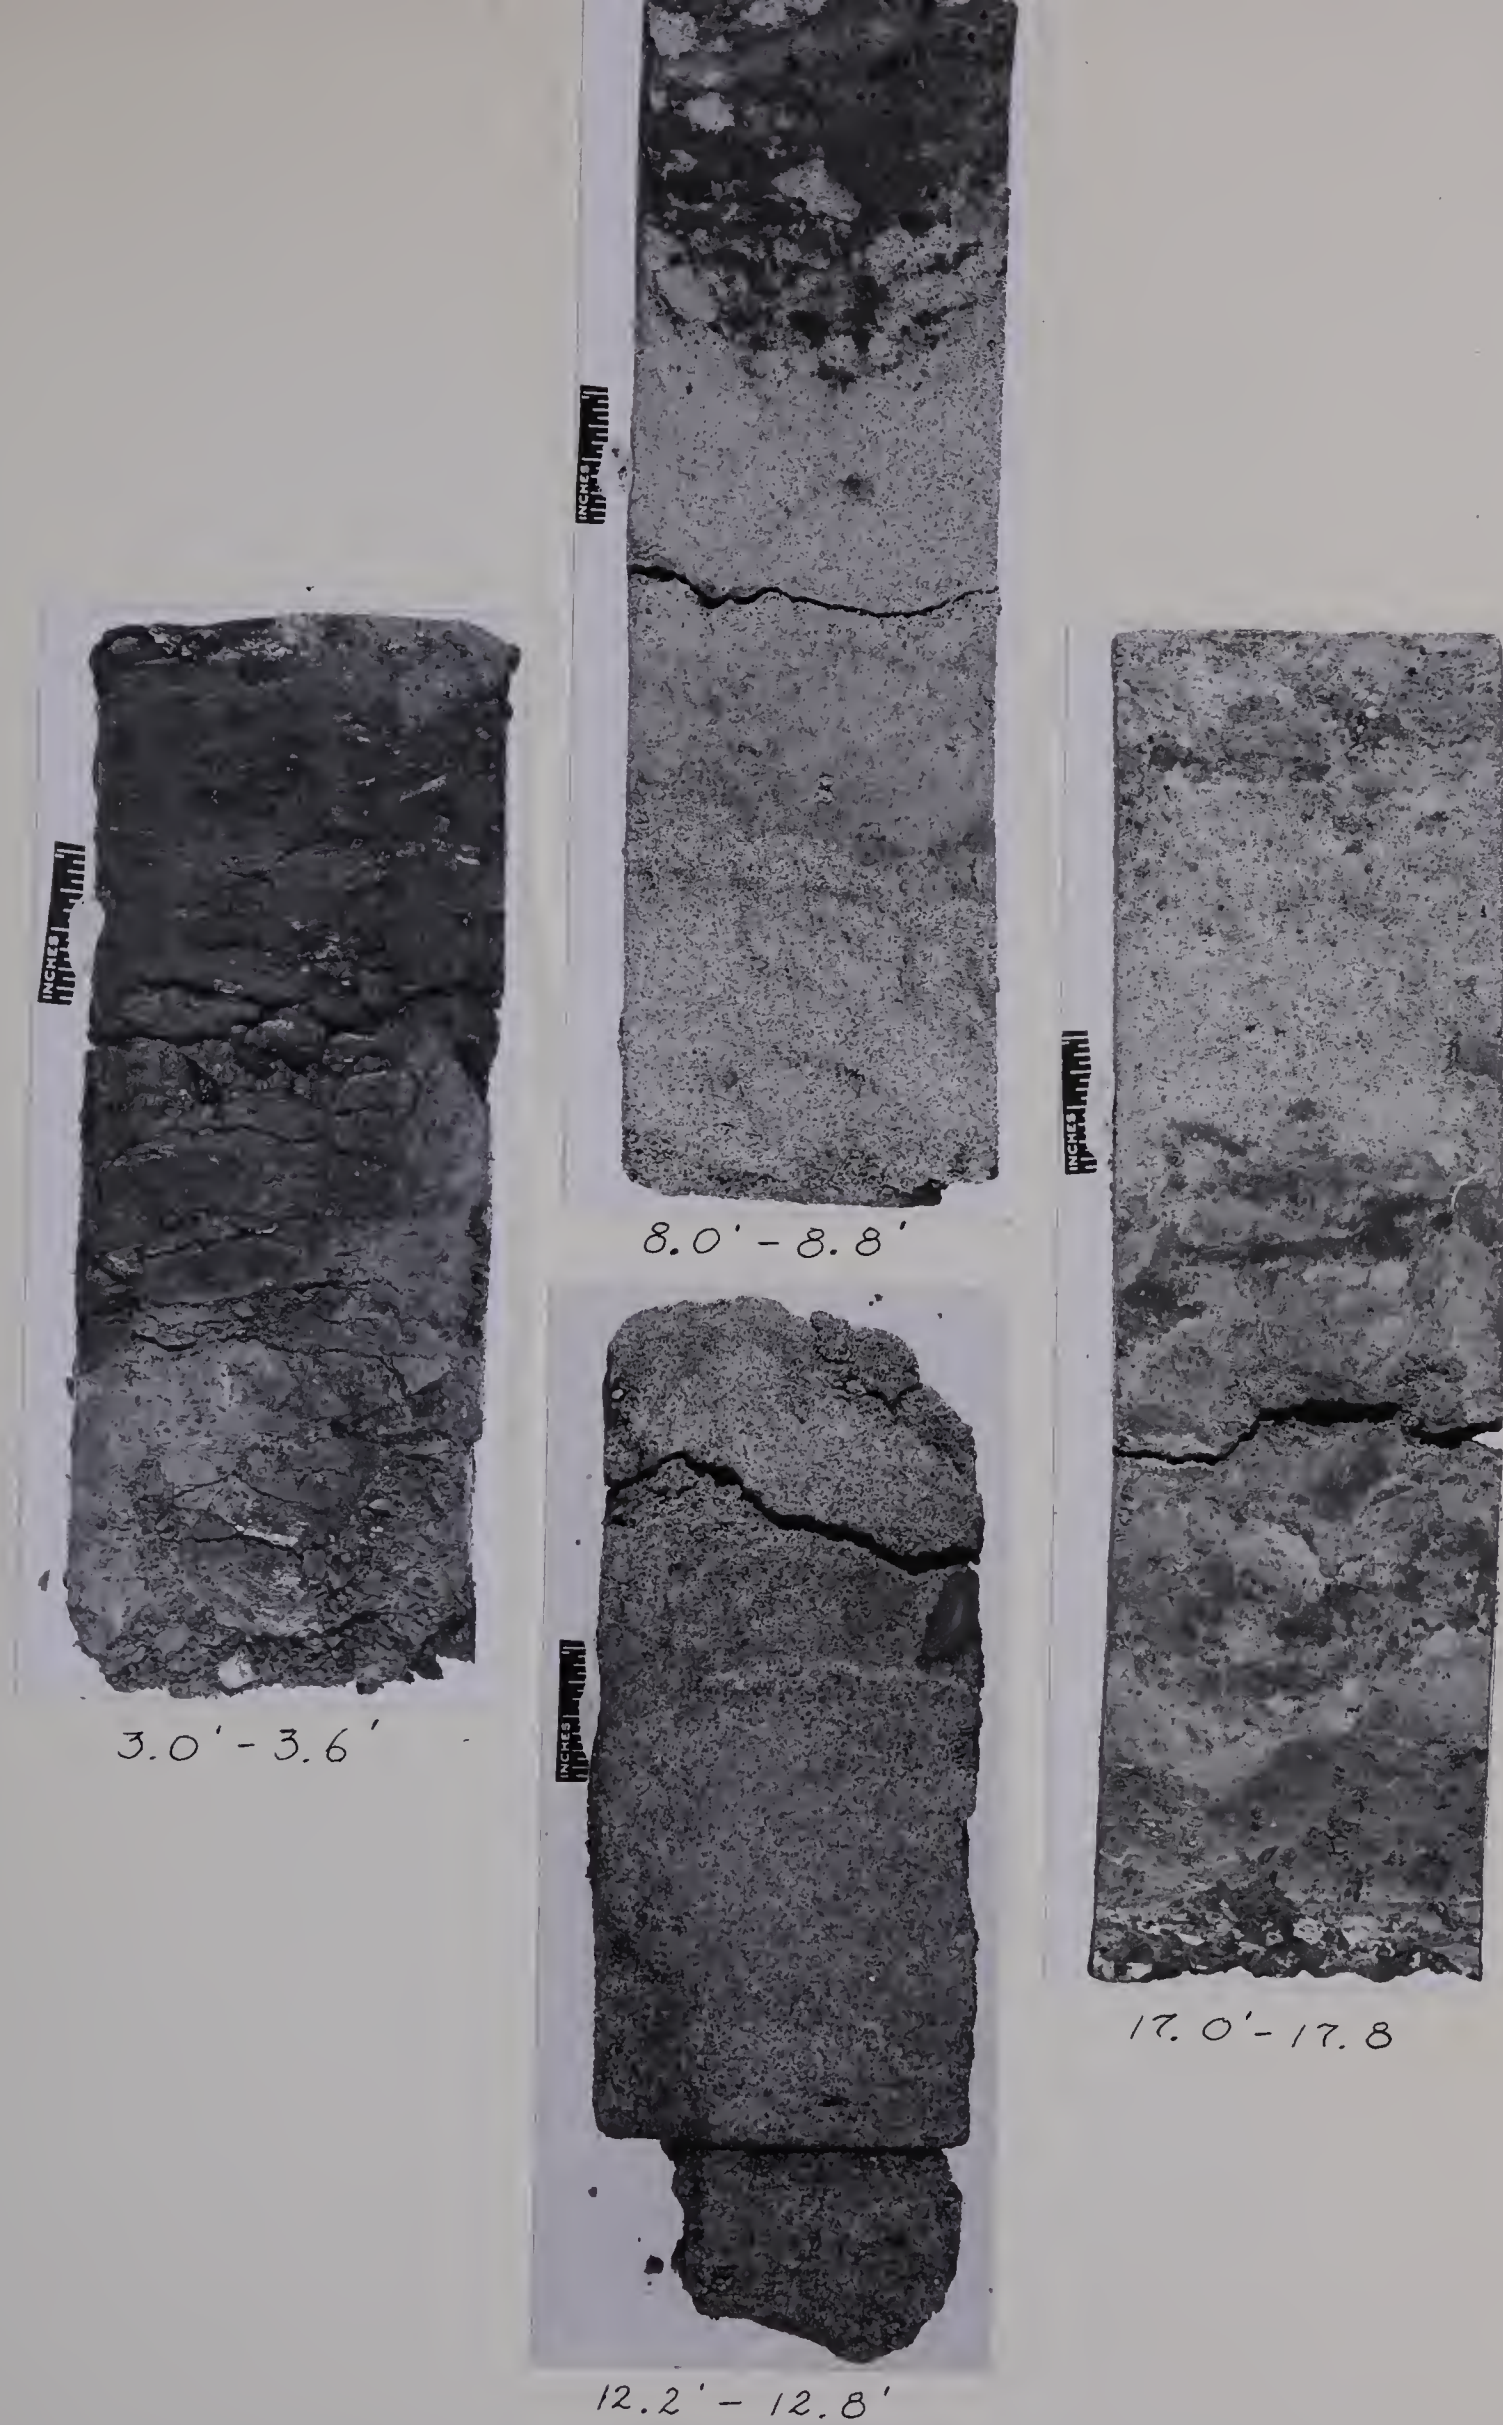
Figure 36.01. Auger hole C-1; axially cut shelly tube samples.

Figure 36.02. Auger hole C-2; axially cut shelby tube samples.

Figure 36.03. Auger hole C-3; axially cut shelly tube samples.

Figure 36.04. Auger hole C-4; axially cut shelly tube samples.

Figure 36.05. Auger hole C-5; axially cut shelly tube samples.

Figure 36.06. Auger hole C-6; axially cut shelly tube samples.

Field inspection of samples recovered from auger holes afforded a crude appraisal of the lithology within the slide material (Plates III to X and Figure 36). Generally, the degree of fracturing, shearing, separating and mixing of material was observed to be directly
